# **PARR SHOALS DAM TURBINE VENTING REPORT**

**PARR HYDROELECTRIC PROJECT**

**FERC No. 1894**

April 2016

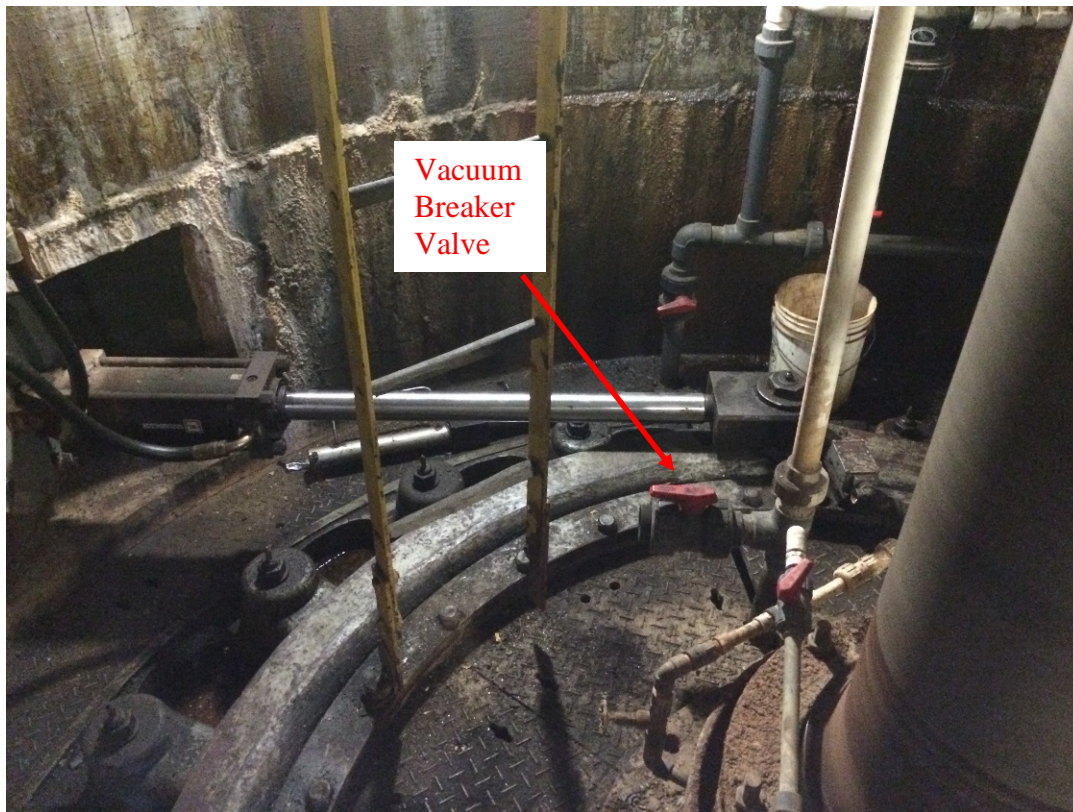
**PHOTO 3-1     PIPING FOR VACUUM BREAKERS IN HEADCOVER**

During the 2014 test, the primary objective was to determine the turbines' physical capacity to self-vent. This requires both the presence of vacuum breakers (which are used during dewatering operations) (Photo 3-1), as well as the proper turbine vertical setting and sufficient gross head to draw air into the turbine during operation. With a turbine operating, the vacuum breaker valve is opened, and venting can be audibly determined. Aeration of the water can also be visually observed in the tailrace (Photo 3-2).

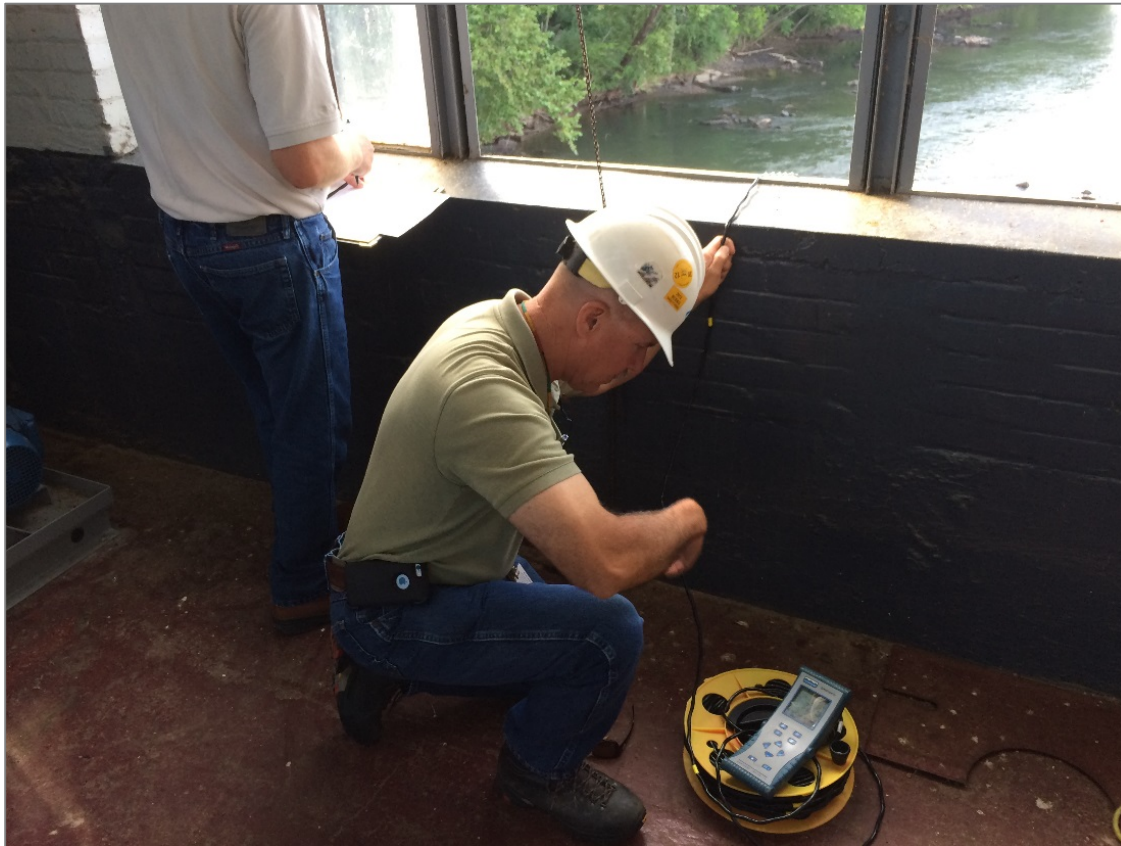
**PHOTO 3-3 MEASURING DO LEVELS DURING TESTING**

Water quality measurements (dissolved oxygen, temperature and percent saturation) were taken using a Hydrolab Surveyor 4a (Photo 3-3). Measurements were made immediately downstream of each turbine both prior to and after the vent was opened. It was verified that the crest gates had not operated within the past several hours, therefore no mechanical aeration influence from spilling was present. Hydrolab readings were allowed to stabilize for several minutes before water quality parameters were recorded.
